HANGAR FLOOR SETTLEMENTS AT THULE AIR BASE, GREENLAND

TECHNICAL REPORT NO. AFWL-TR-69-122

March 1970

An investigation has been made of hangar floor settlement problems at Thule Air Base, Greenland. Inspection of existing instrumentation and soil-cooling systems were accomplished. Results of this inspection are presented. Existing temperature sensors were found to be in excellent condition; however, readout capability was poor. Pumping of ground water has removed no fines from the fill which might have caused settlement. Major cause of settlement was found to be thawing which has contributed to settlement. Duct blockages in the soil-cooling system has also allowed thawing to occur resulting in settlement. Recommendations are made to control further hangar settlement. Blocked ducts in the soil-cooling system should be cleared on an annual basis. The water table should be lowered by lowering the water level in nearby Lake Eddy. Recommendations were also made to improve instrumentation in order that effective operation and maintenance procedures for hangar foundation could be developed.

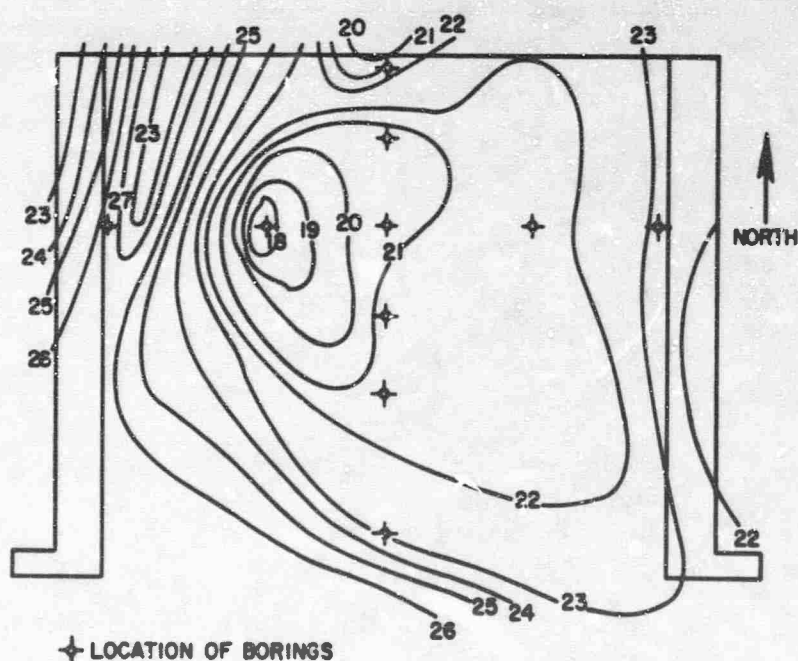
Figure 9. Distance in Feet from Finished Floor to Native Soil below Hangar 10 as Found from Soil Borings in 1953

In 1953 numerous holes were drilled through the floor of hangar 10 and into the soil below for installation of thermocouples. The soil boring logs were reviewed and a map produced showing the distance from the hangar floor to the native soil (figure 9). Boring logs indicate that the upper 6 to 24 inches of native soil generally contains little ice and probably would not produce noticeable floor settlement upon thawing. Nevertheless, the thaw danger line has been assumed as the upper boundary of the native soil.
